ARLINGTON FINANCE COMMITTEE
MINUTES OF MEETING
03/8/2023 7:30 PM
Via Remote Participation - Zoom

ARLINGTON TOWN HALL EXTERIOR CONDITIONS ASSESSMENT & RECOMMENDATIONS

December 2022

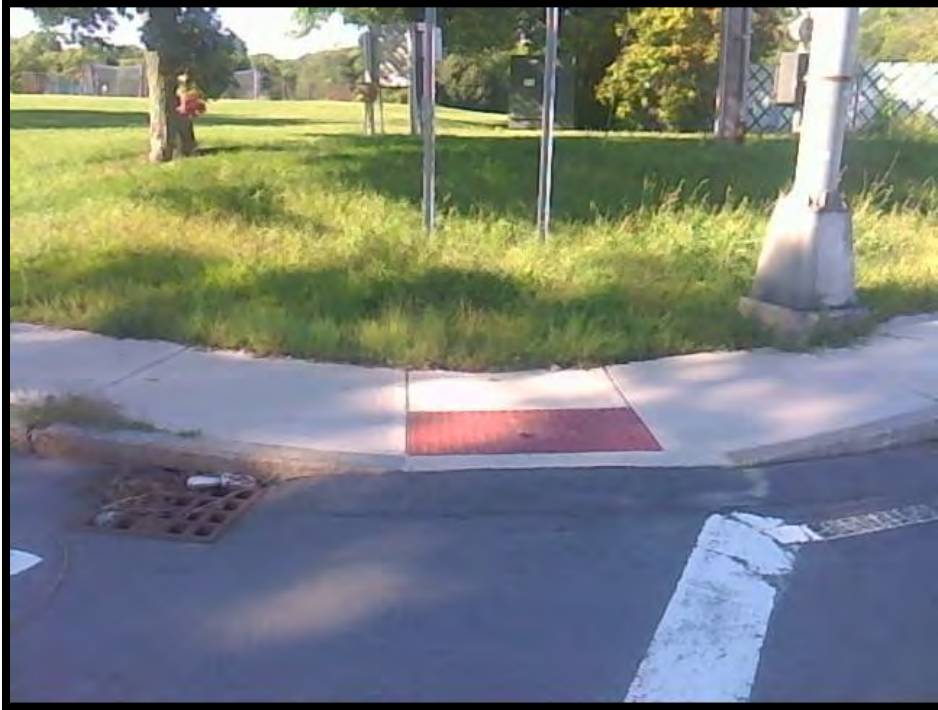
Excellent Condition Ramp – Concord Turnpike and Dow Avenue

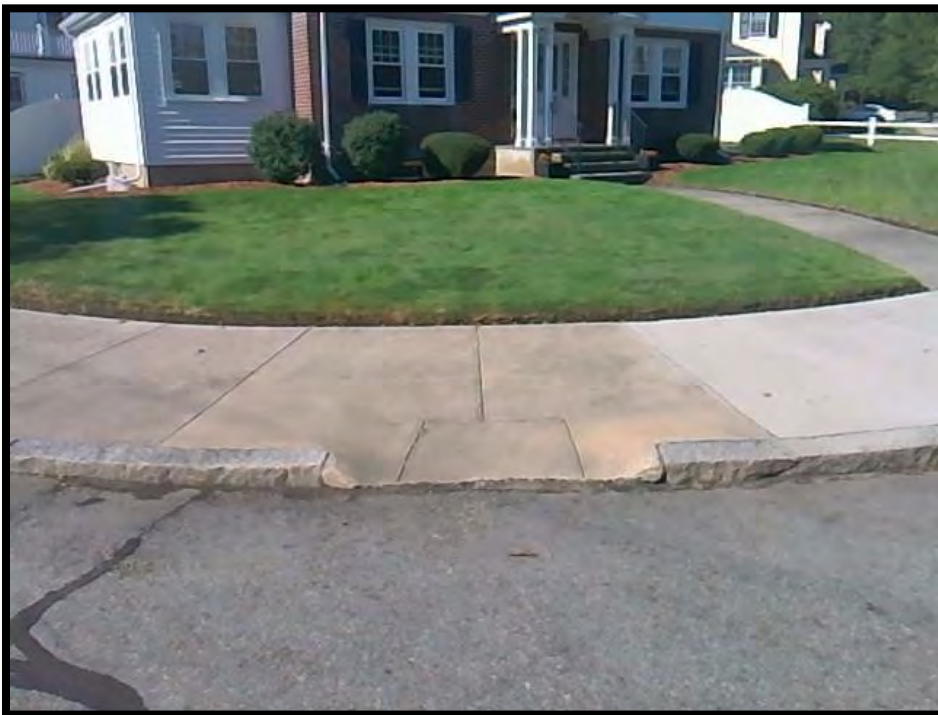
Good Condition Ramp – Radcliff Road and Victoria Road

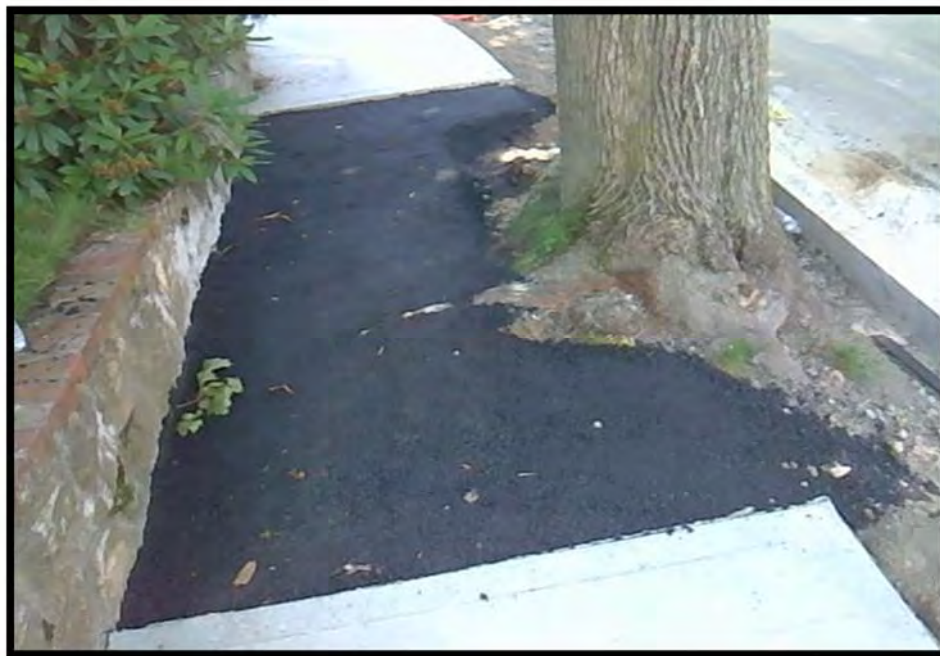
Tree Severity Low – Churchill Avenue

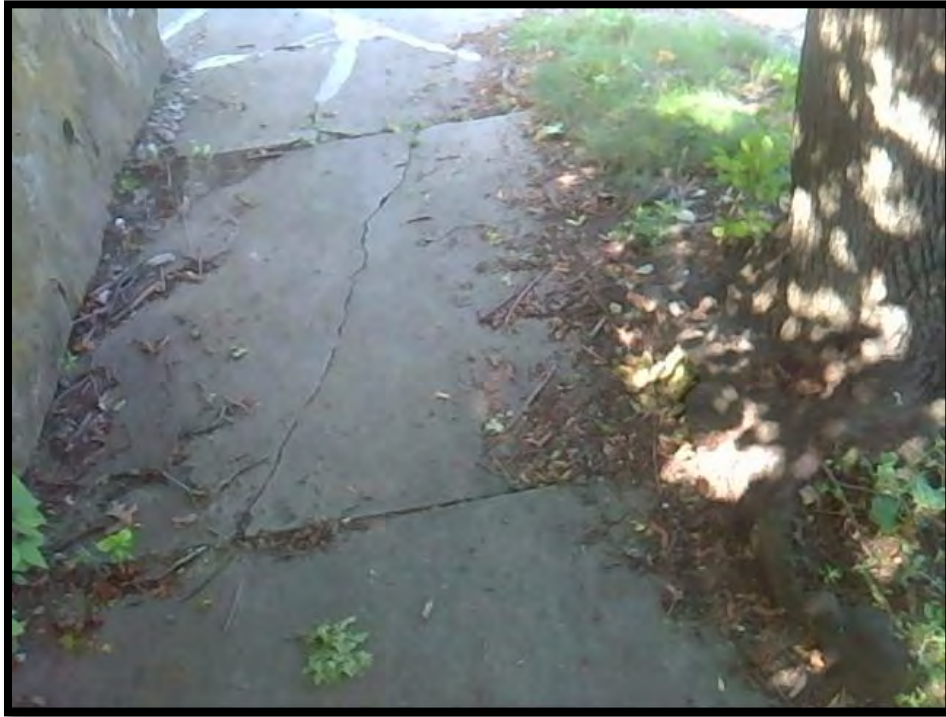
Tree Severity Medium – Quincy Street

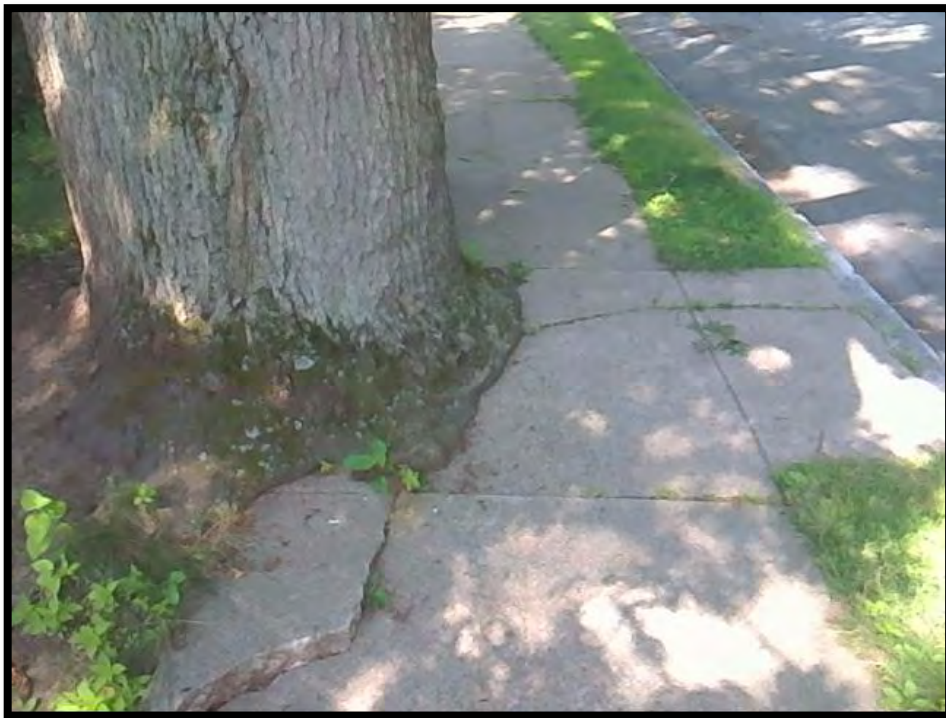
Tree Severity High – Glenburn Road

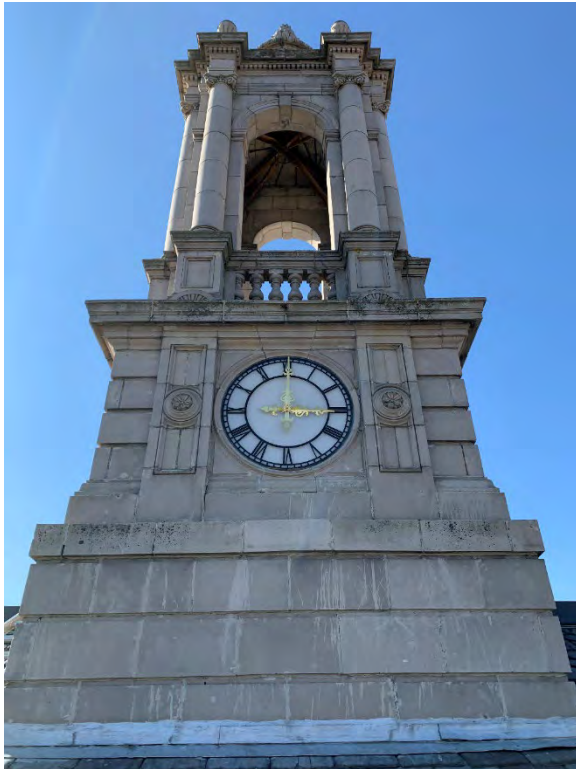
Figure 1: Cupola north elevation

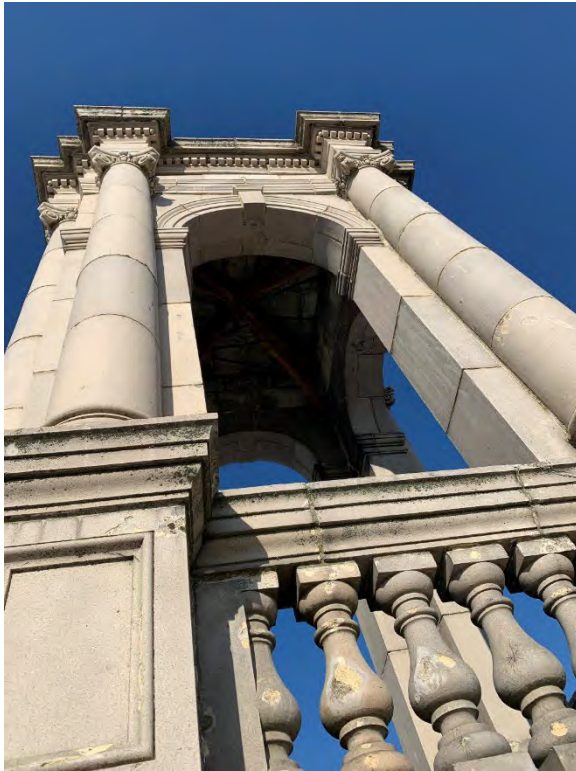
Figure 2: Note failing glazing on terra cotta

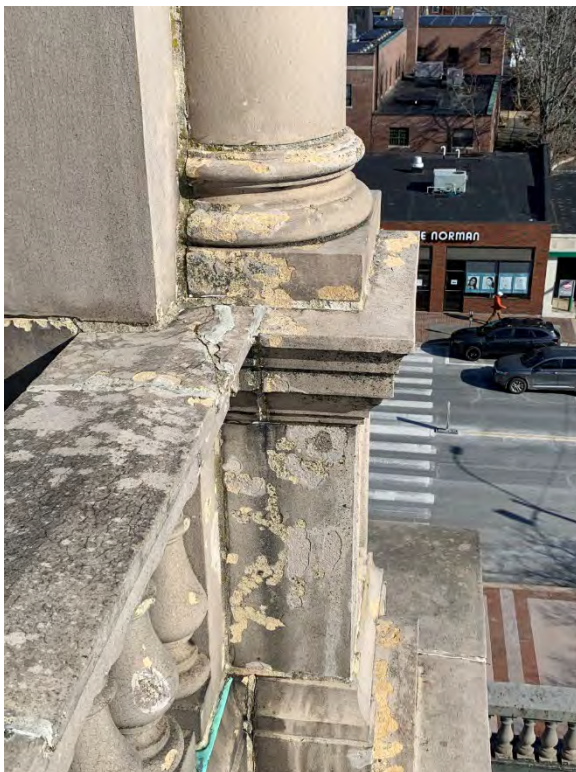
Figure 3: Detail of cracking and failing terra cotta

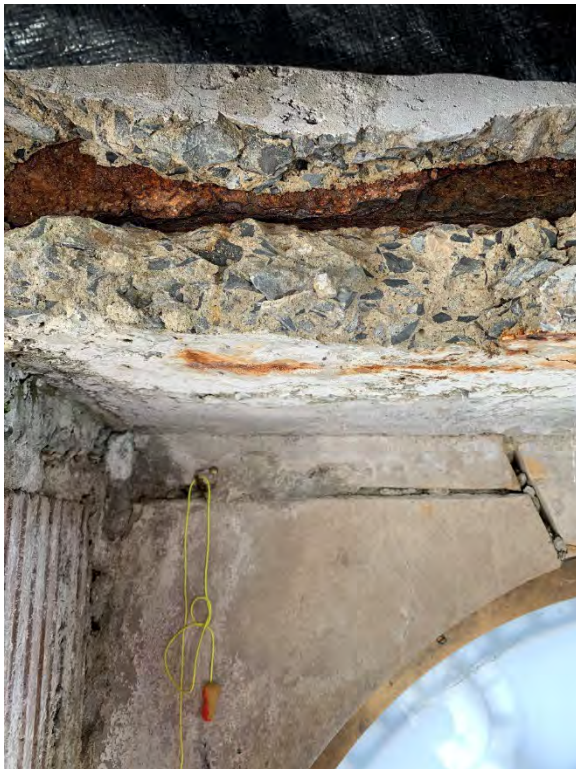
Figure 5: Rusting structural steel cracking encasing concrete

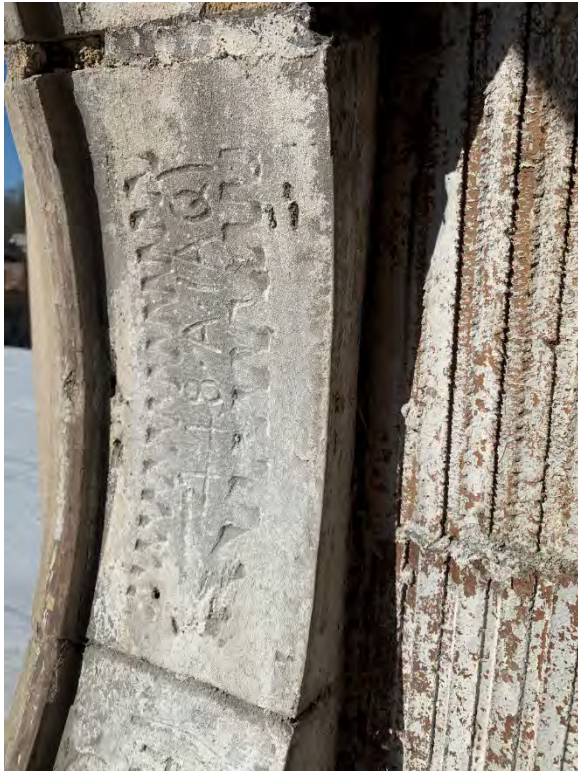
Figure 8: Decorative terra cotta and structural terra cotta

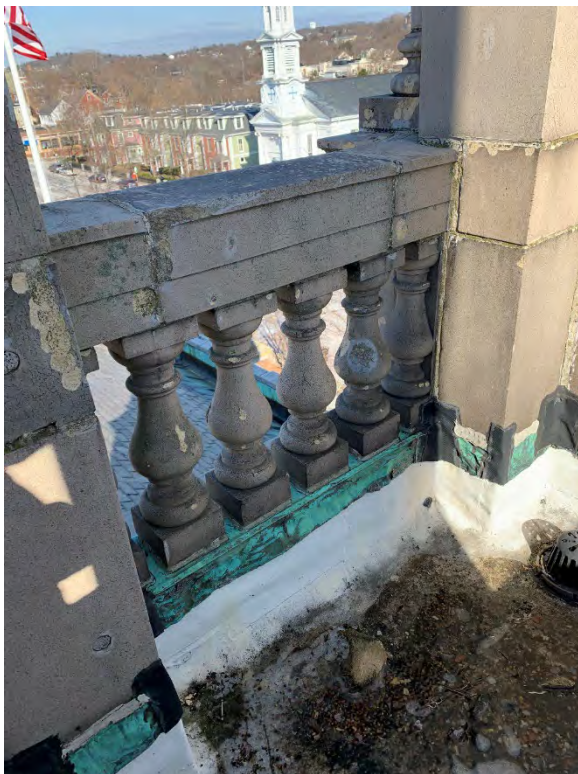
Figure 9: Failed glazing and cracking

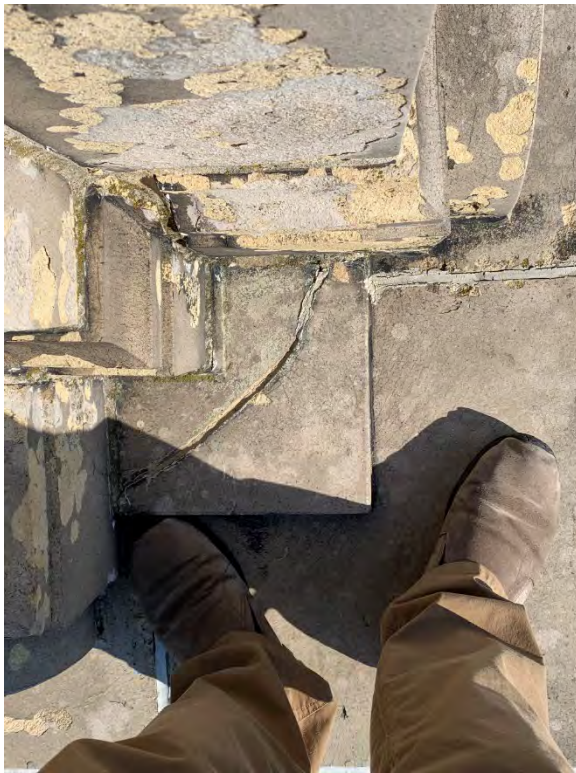
Figure 10: Failed glazing and cracking

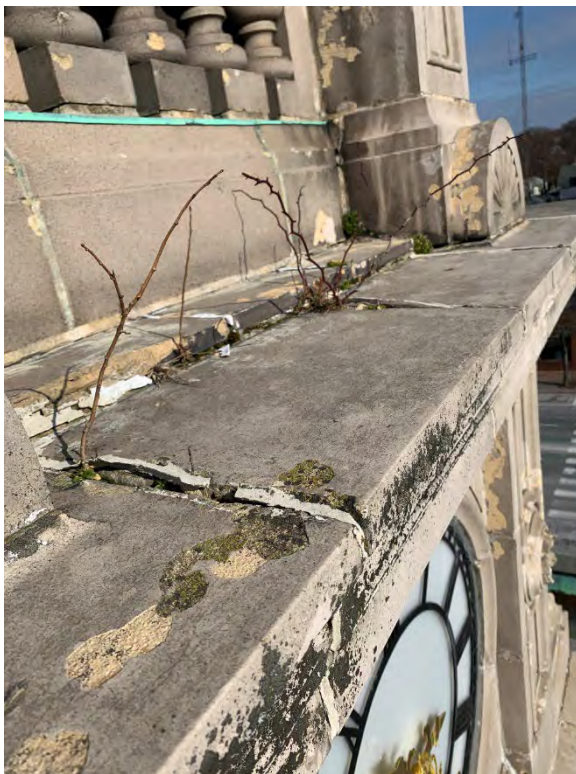
Figure 11: Failed caulking at joints, plant colonies, failed glazing and cracking

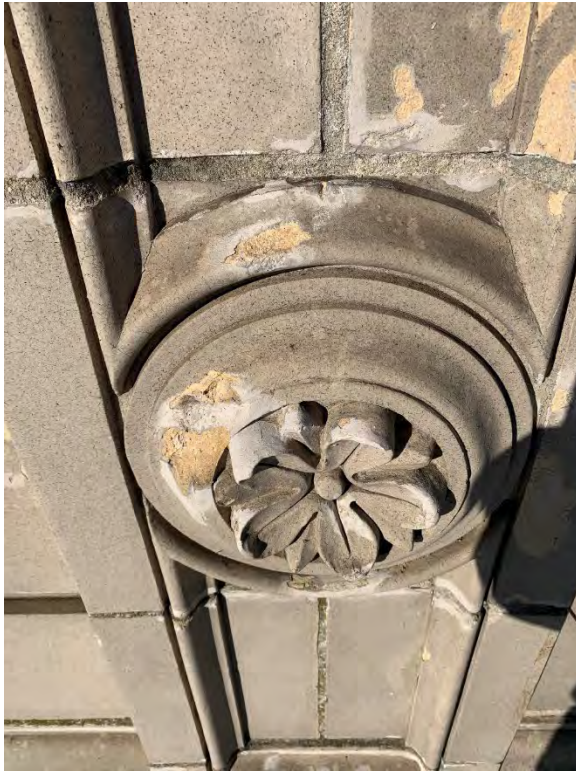
Figure 12: Deterioration of decorative piece

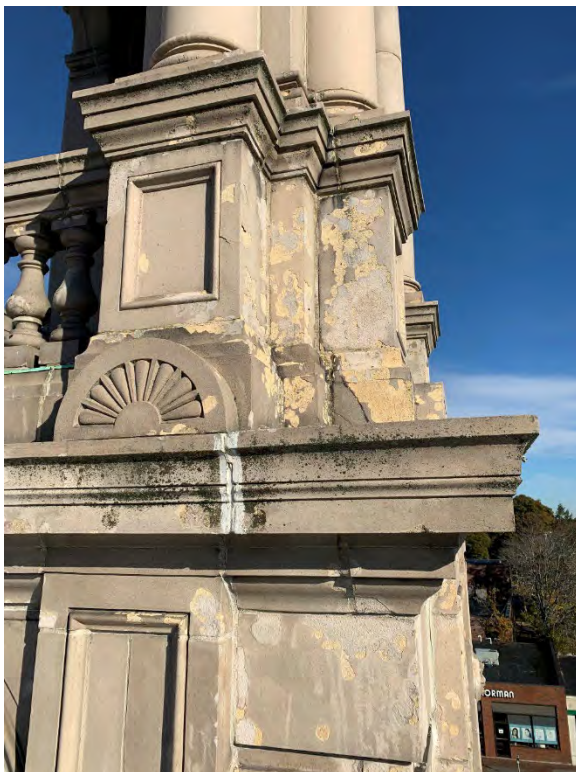
Figure 13: Failure of glazing and cracking

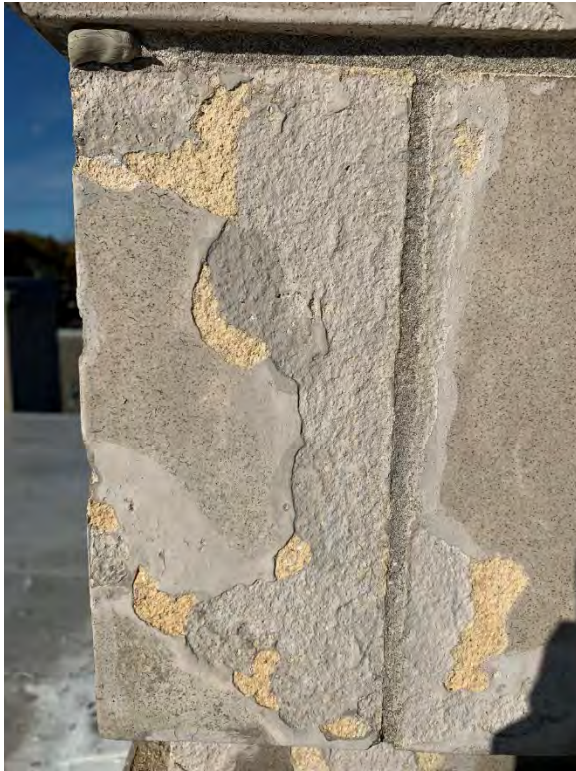
Figure 14: Failure of glazing revealing the softer underlying ceramic

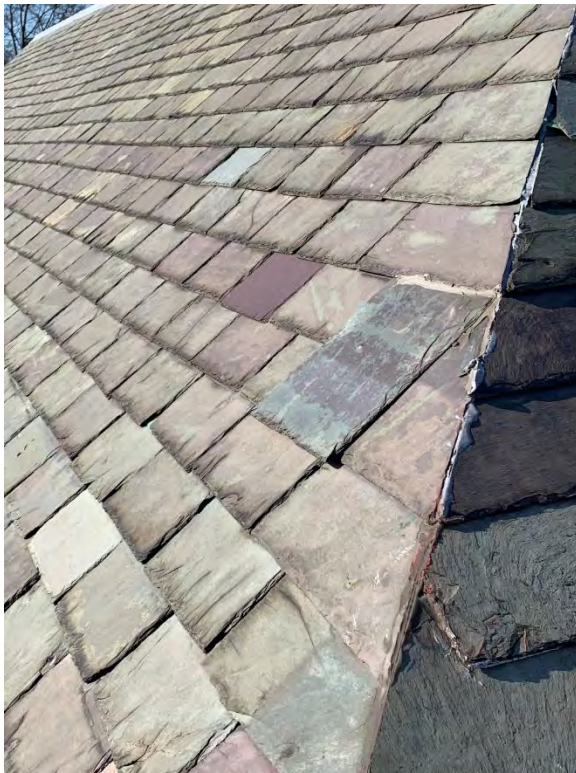
Figure 16: Broken hip slates, mis-matched sizes and colors at repairs,

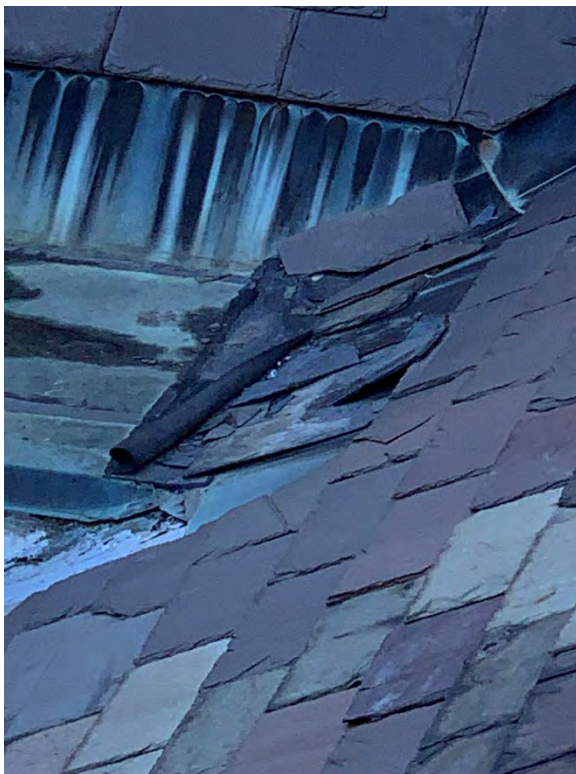
Figure 17: Slates that have fallen off roof and broken slate debris at one of the roof valleys

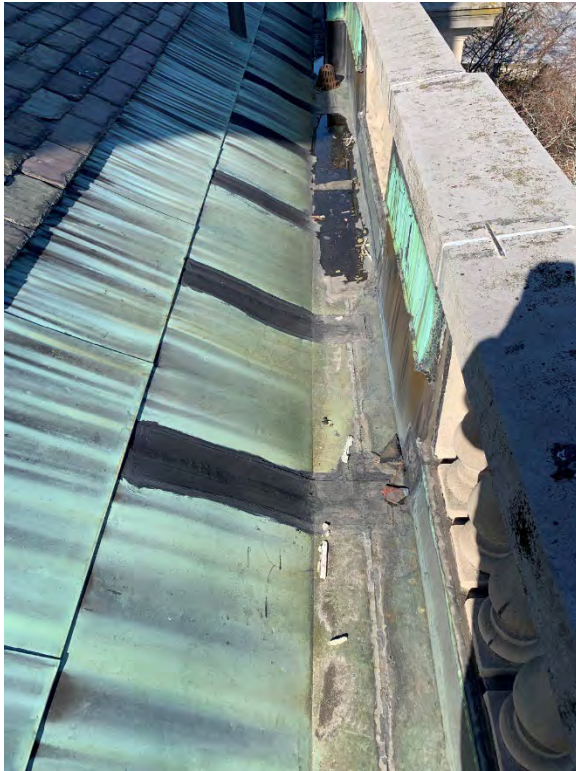
Figure 18: Standing water, cracked solder joints and rubber patching at the base of the slate roof along the parapet

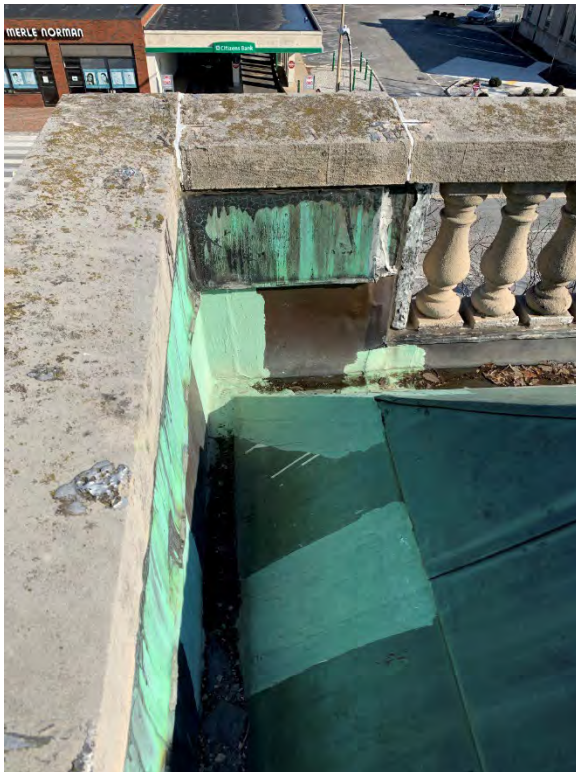
Figure 19: Pitted copper flashing at the base of the slate roof and water running out from under the copper.

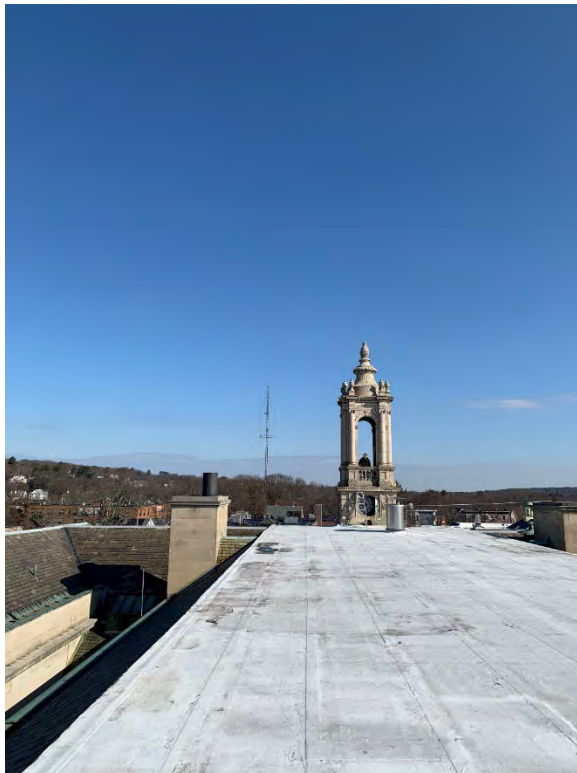
Figure 20: Coating applied to the torch-down flat roof of the auditorium is wearing out along seams

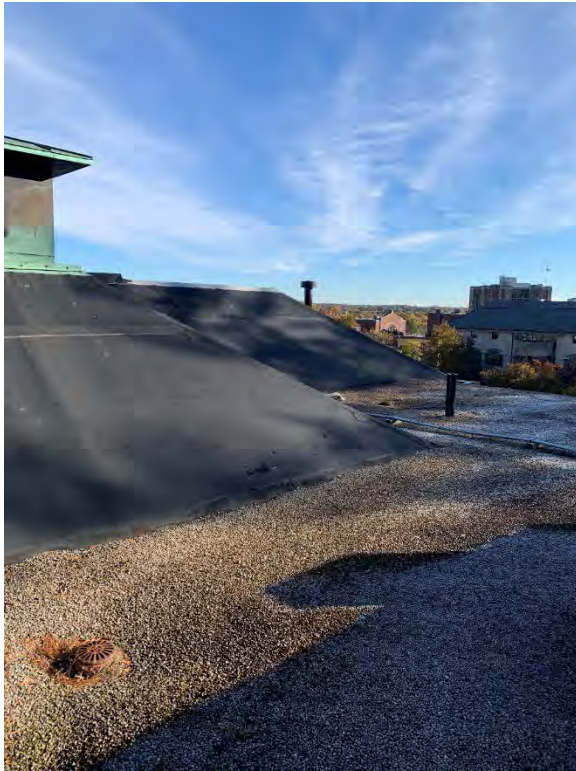
Figure 21: Tar and gravel cover the Annex roof and membrane covers the south slopes of the Town Hall roof. Note the standing water in the equipment shadows on the Annex roof.

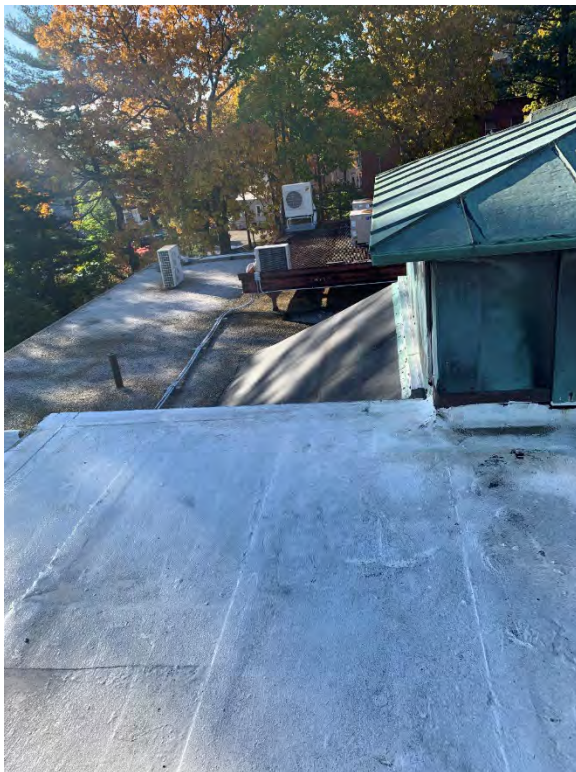
The flat roof of the auditorium has been painted with a fibrated coating to extend the life of an older flat roof below. The coating is cracking and peeling. Flat roofing at the porte cochere, side aisle and Annex appears to be torch-down roofing with gravel on top. Standing water was observed around roof-top equipment. There are approximately 10,500 square feet of flat roofing. According to evaluation by Paul F. Dutelle Company, the roofing is near the end of its service life.

Figure 22: Edge of auditorium roof looking toward Annex roof. Stage ventilator is at the right side.

Remove the existing roof, ballast, and underlayments down to the sheathing. Replace with a vapor barrier, tapered insulation, Dens Deck, fully adhered light-colored TPO, and copper edge flashing around the perimeter. The light color will help with Town Hall and Annex cooling costs.

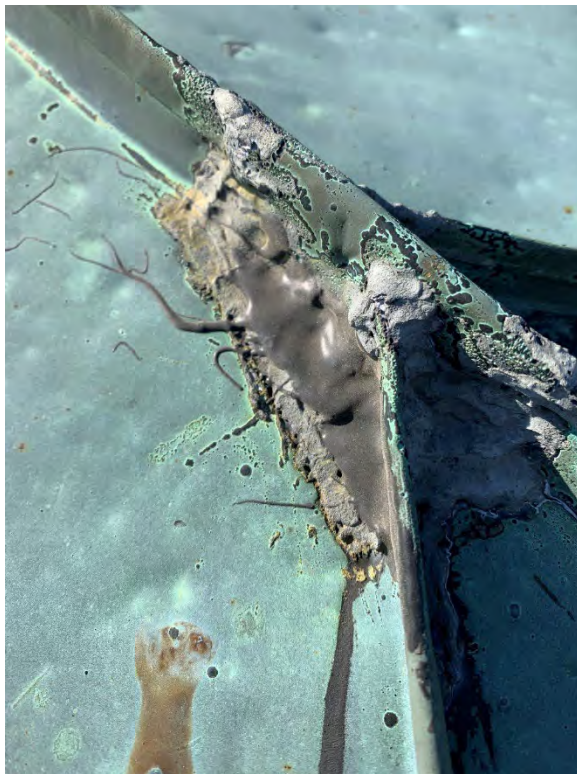
The headhouse of the auditorium stage, mechanical headhouses at the auditorium flat roof and vents at the town hall roof are copper with pyramidal roofs. The auditorium stage head house is standing seam with a skylight in the south plane of the pyramid. The roofs are metal at the end of their service life.

Figure 23: Typical condition at standing seam roofing with solder and caulking repairs over pitted copper.

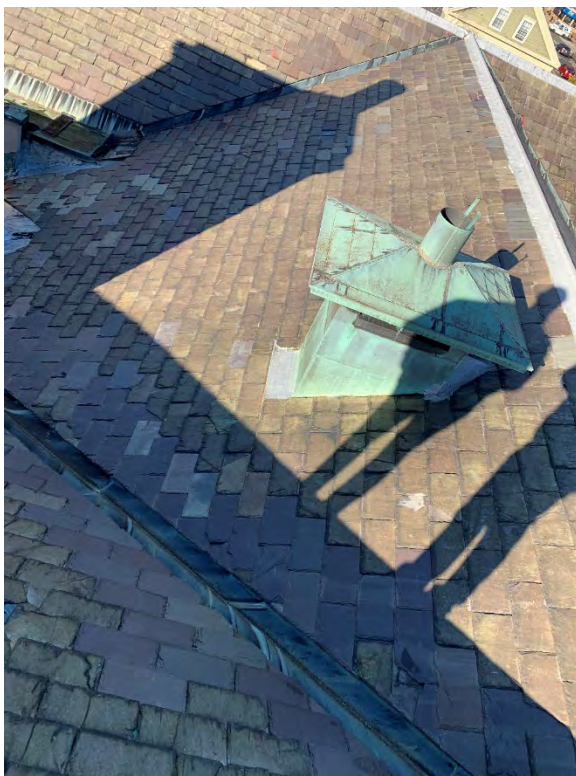
Figure 24: Ventilating head house at main block gable. Note open ventilator pipe missing its cap and fatigued solder joints.

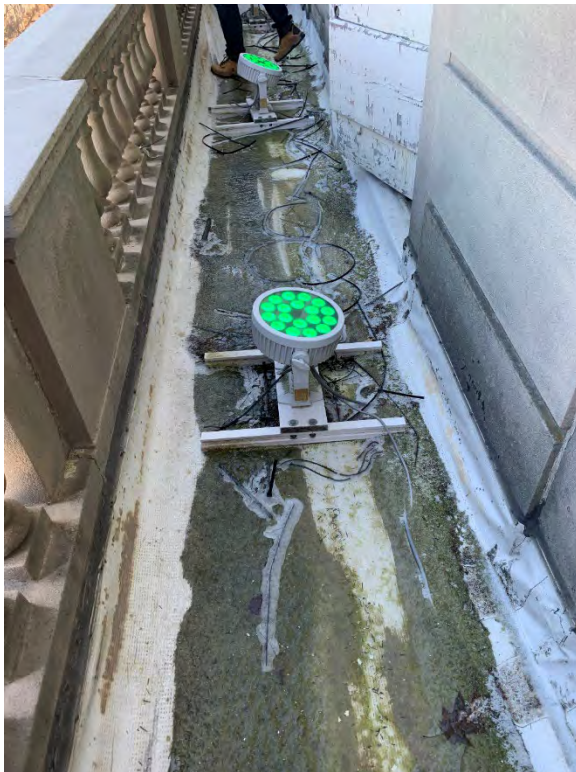
At the entry portico, the roof is flat seam metal with a loosening membrane cover regletted into the stone parapet. The portico roof is about 120 square feet.

Figure 25: White membrane applied over flat seam metal at the portico roof. Note the reglets anchoring the white, loose membrane and accumulated debris due to ineffective drainage.

At the Town Hall entry portico remove the existing covering, roof and coating and underlayment. Install a new flat seam roof, pitched to drain to scuppers. Coordinate this work with masonry repair. Remove the stone balustrade and provide through flashing/roofing at the base during the roof replacement.

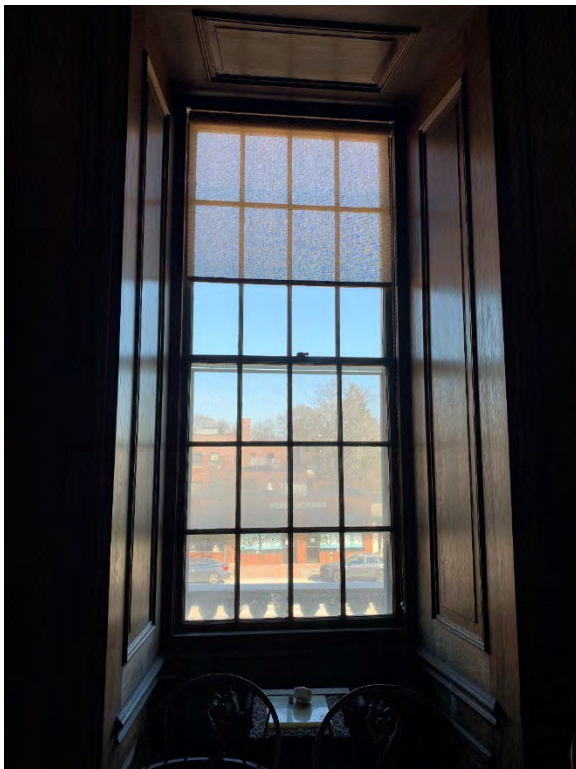
Town Hall wood windows have weathered nearly ten decades. Aluminum storm windows have helped protect them, but exterior glazing is failing, years of gouging by opening or closing when the locks were not fully secure have left wood of meeting rails and muntins in need of repair. Sash cords in double hung windows have frayed and broken. Casement hardware is frozen. All the Town Hall windows are painted on the exterior and have clear finish on the interior. Exterior paint is failing and recent window restoration detected lead paint at the sash and trim. There are 110 windows at the Town Hall that range in size from 8 to 30 and as large as 70 square feet. Windows were evaluated by Design Associates in consultation with Kronenberger and Sons who recently restored two windows at the Town Hall.

Figure 26: Town hall windows are large, multi-lite, single-glazed, double hung units. Interiors are clear finish and exteriors are painted.

Remove sash and record location for reinstallation. Retain existing storm windows for weather protection until restored units are reinstalled. Remove glass and glazing and paint from sash. Dispose of lead paint and hazardous materials in caulking and sealants. Repair damaged wood with wood Dutchmen. Reinstall glass and reglaze windows. Paint exterior, including the trim. Refinish the interior, staining to blend with existing woodwork in each room. Check and adjust hardware. Replace all sash cords with sash chains Refinish jambs and sills, staining as necessary to match adjacent woodwork.

Replace aluminum storm windows with new, two-track, single-hung, aluminum storm windows custom fit to openings.

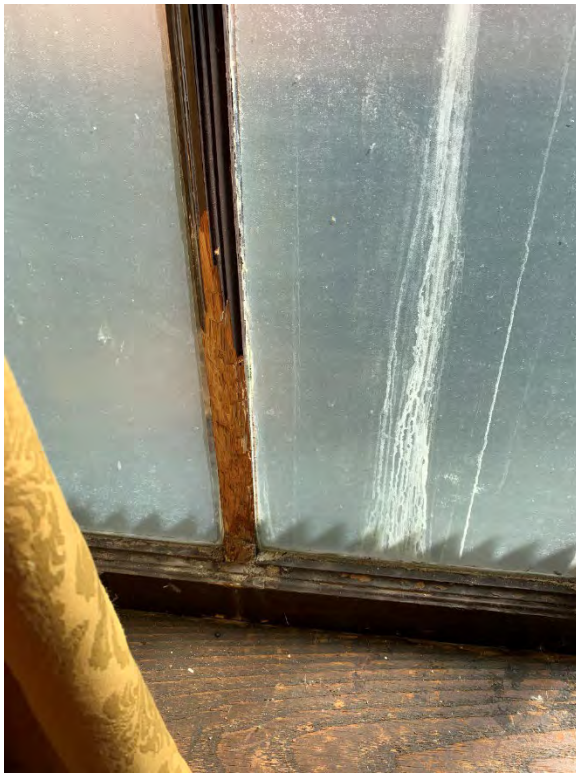
Figure 27: Many muntins, like this one at the auditorium, require replacement.

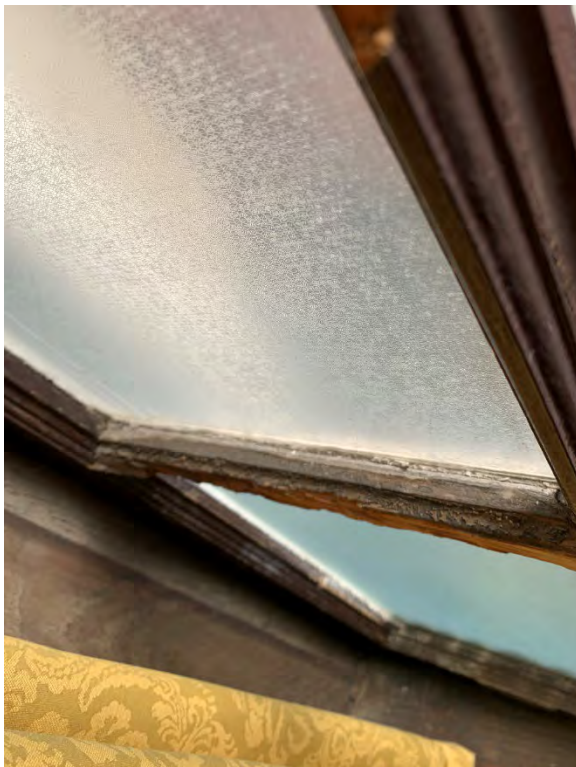
Figure 28: More damage at the auditorium.

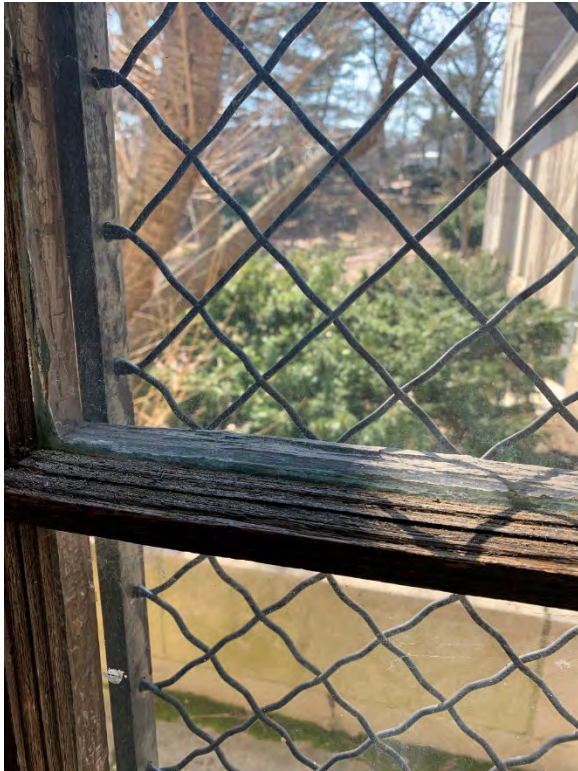
Figure 29: Window interior wood is dried out and needs treatment. Exterior glazing is also failing and needs replacement.

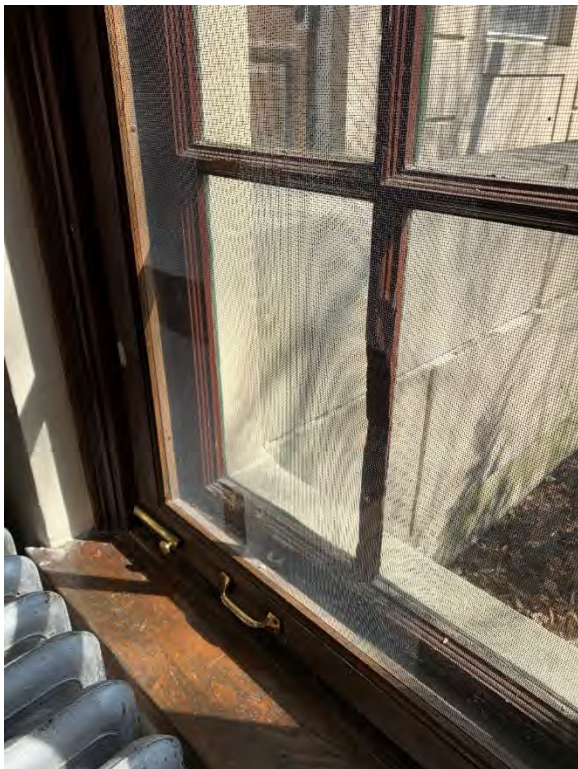
Figure 30: Another damaged muntin.

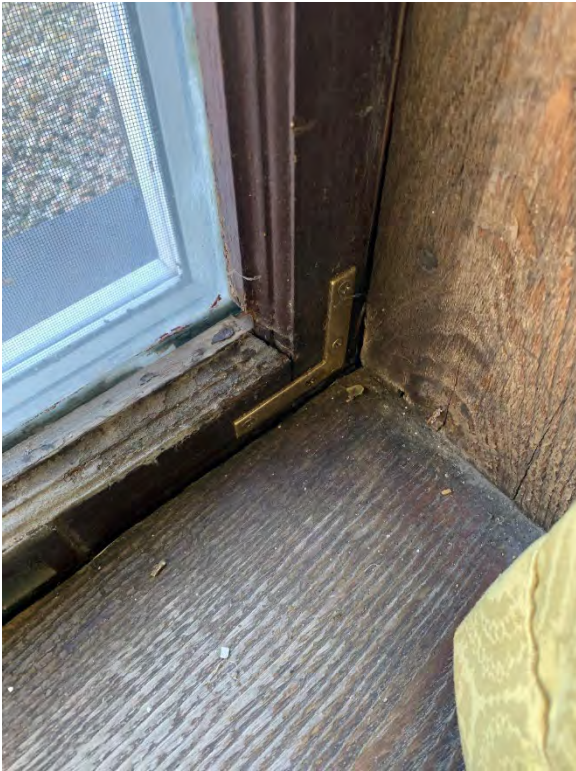
Figure 31: Temporary repair to a window joint.

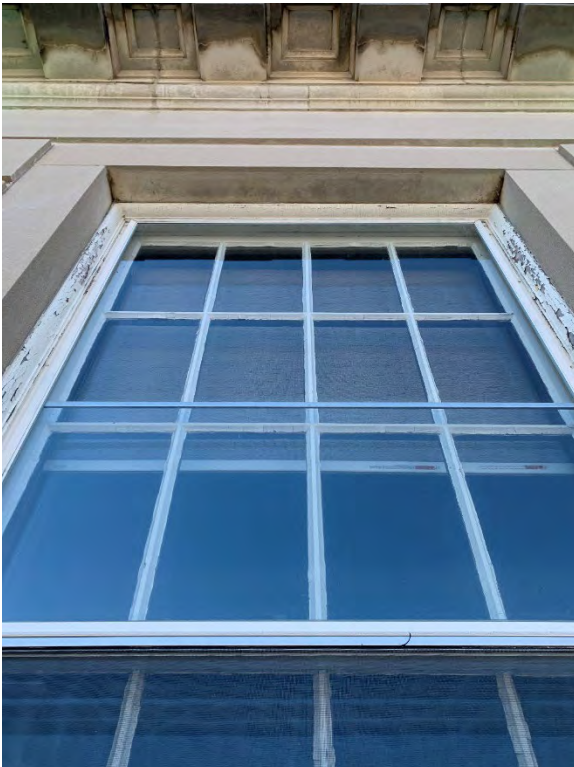
Figure 32: Exterior aluminum storm stuck in a partly open position.

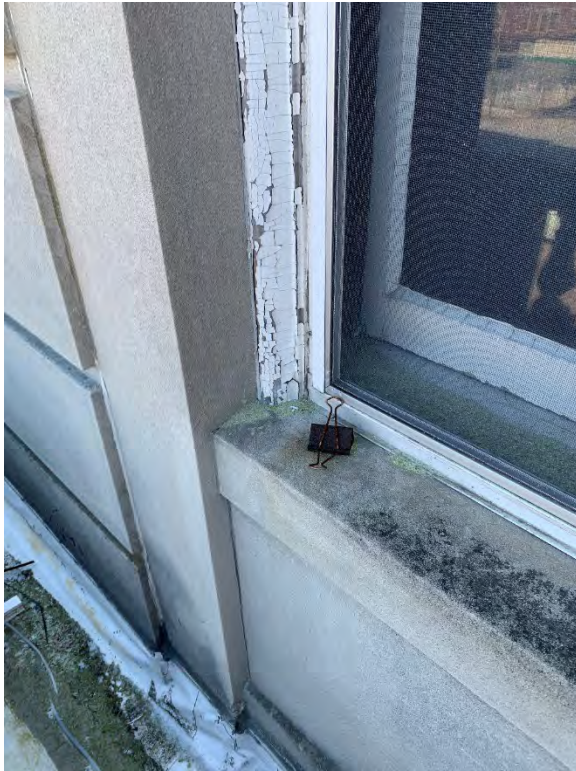
Figure 33: All exterior woodwork at windows is coated with failing lead paint.

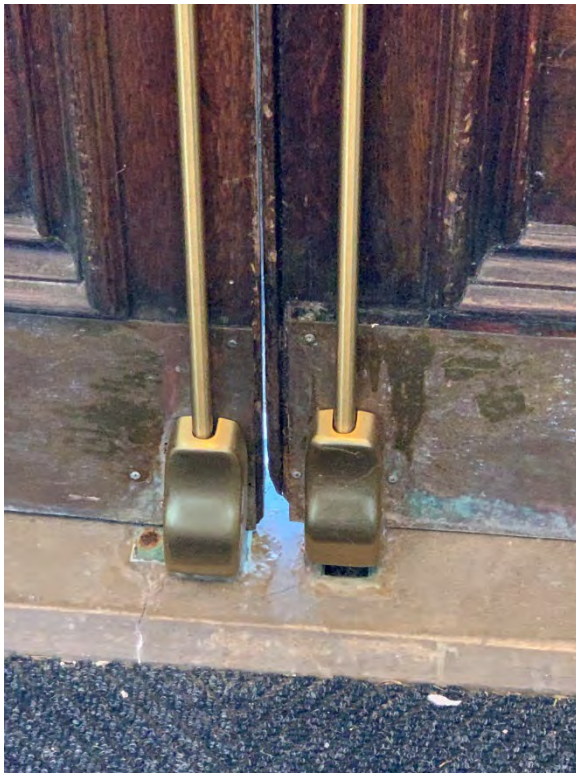
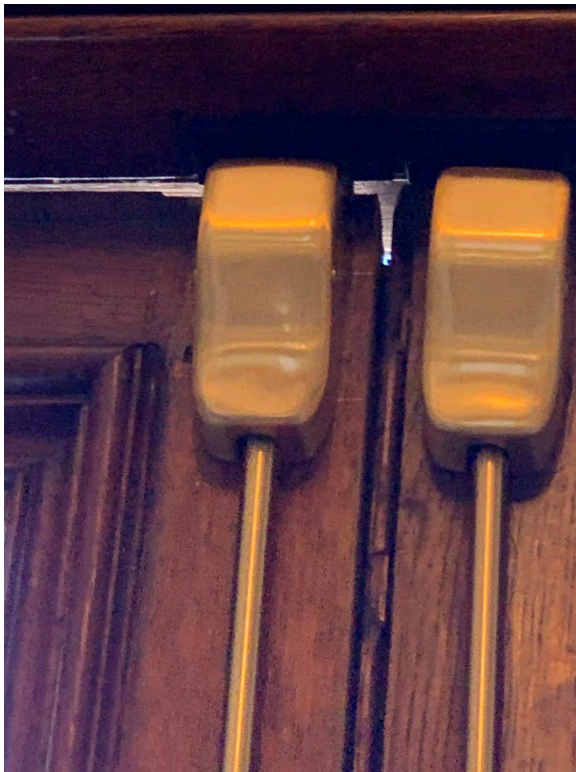
Figure 36: Bottom and top rails of doors are worn and do not provide good weather seal.

Figure 37: Bottom and top rails of doors are worn and do not provide good weather seal.

Dismount, remove hardware and epoxy repair the stiles and rails of the Town Hall entry doors. Stain wood to match adjacent wood and provide a satin finish clear coat to the wood. Refinish the wood trim at the opening. Adjust the automatic openers so door pairs are properly coordinated for opening and closing. Replace weatherstripping and adjust the resistance on the manual closers to make door opening easier. Reduce, if possible, the use of de-icing salts.

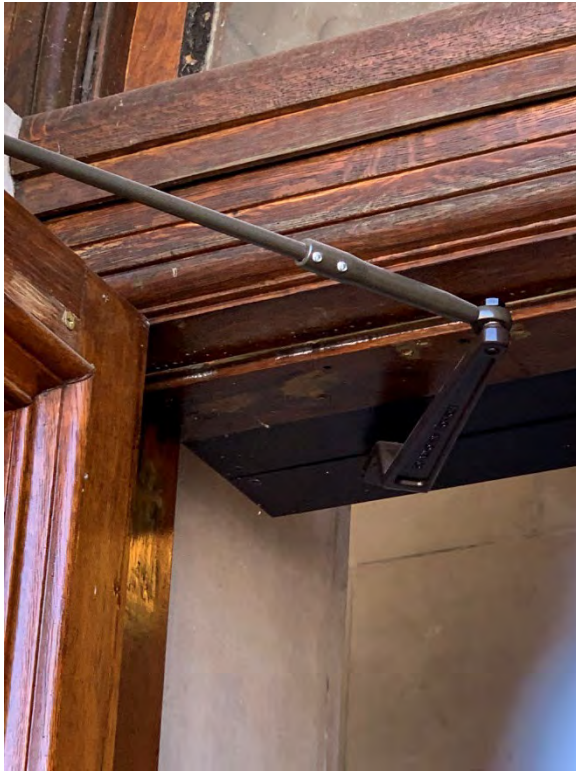
Figure 38: Adjustment to the automatic door opener coordinator device is required.

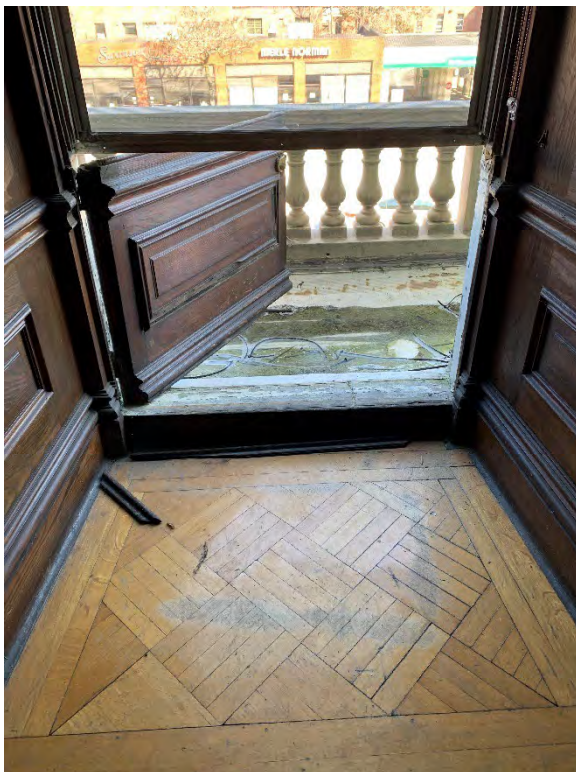
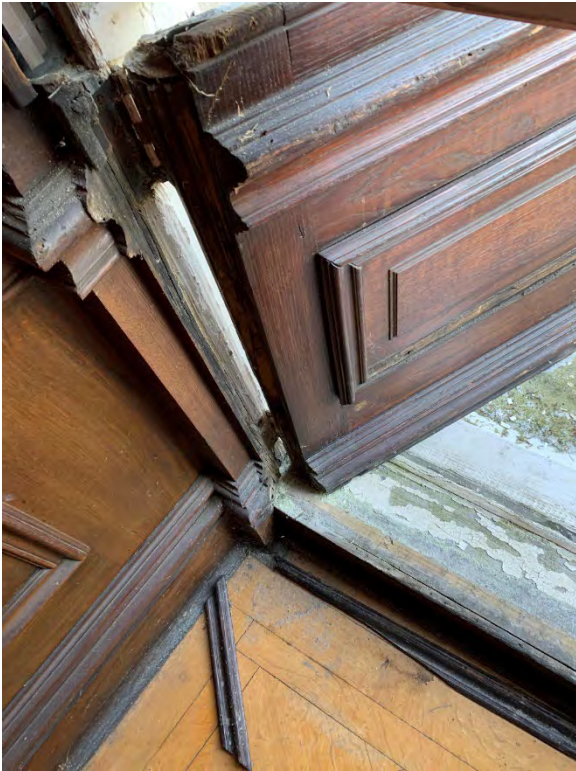
Figure 39: The half-door onto the portico balcony has fallen apart and needs to be re-built.

Figure 40: Pieces are falling from the half door to the portico balcony.

Reconstruct the Lyons meeting Room balcony door, retain hinges, provide new latch, weatherstripping, sill pan flashing. Upper half of opening is an operable window that will be repaired under the window repair project but with weather stripping and hardware coordinated with the door for a good weather seal.

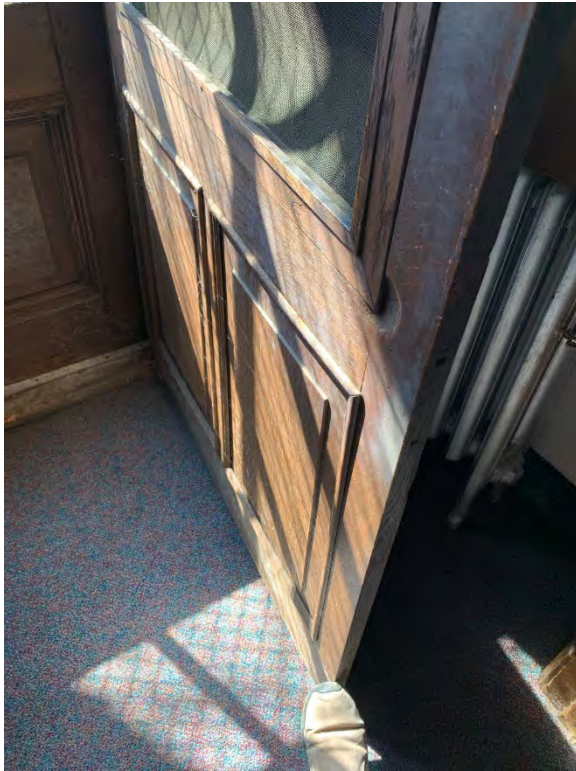
Figure 42: The woodwork of the screen door and original door requires refinishing. Weatherstripping should be applied and the hardware adjusted.

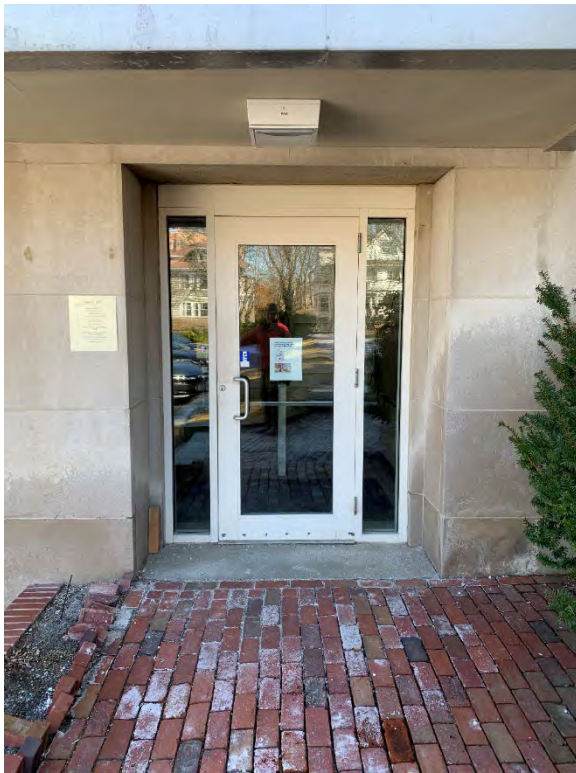
Figure 44: Entry to the Annex. Door weatherstripping should be replaced. Note the light fixture and sagging ceiling plaster at the awning.

Replace the weatherstripping at the aluminum entry doors and adjust automatic and manual closing mechanisms.

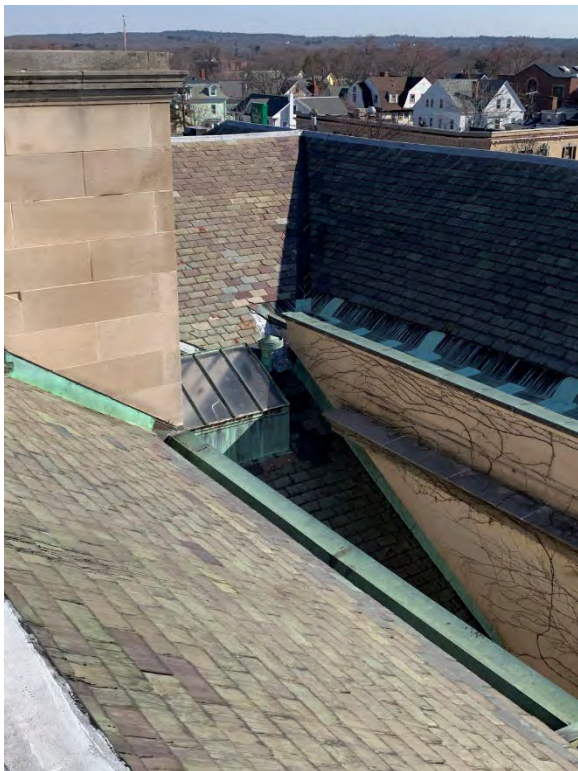
Figure 46: The east shed skylight. The worn copper and cracked glass are evident.

Restore the restroom skylights. Remove and replace the exterior copper cladding. Build new frames with insulated, laminated, safety glass conforming to current code requirements. At the stage skylight, and while the ventilator head house is being clad in copper, reconstruct the skylight at the

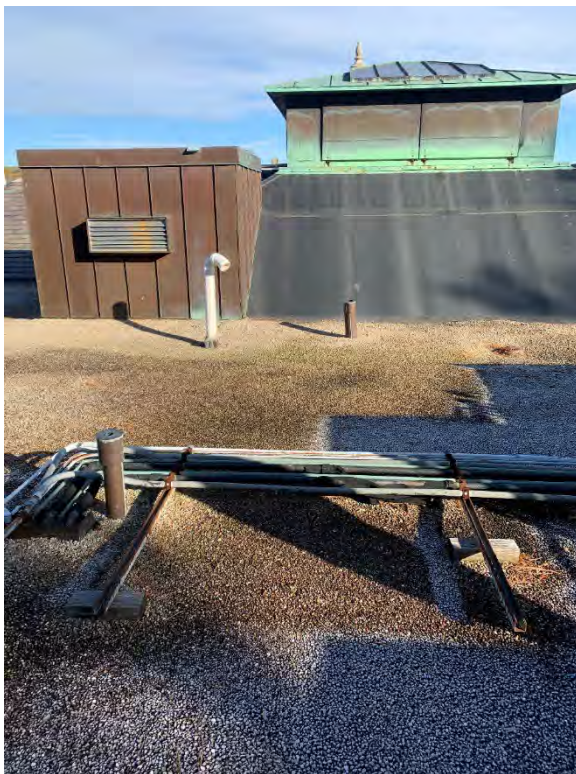
Figure 48: The stage skylight is visible at the ventilation monitor. It should be repaired when the monitor copper is replaced.
